## Trench Repair in Electro Plating Workshop

Client LTQ

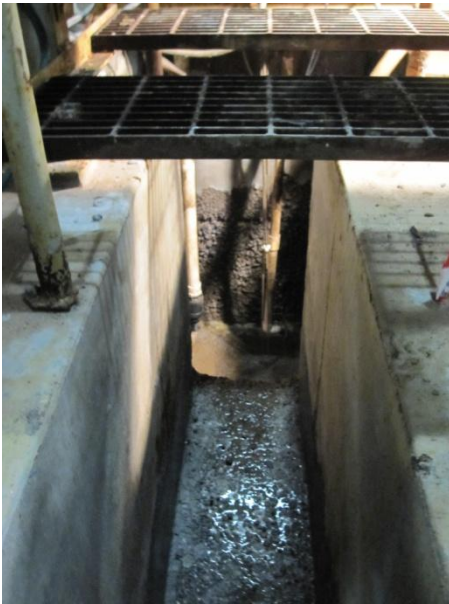
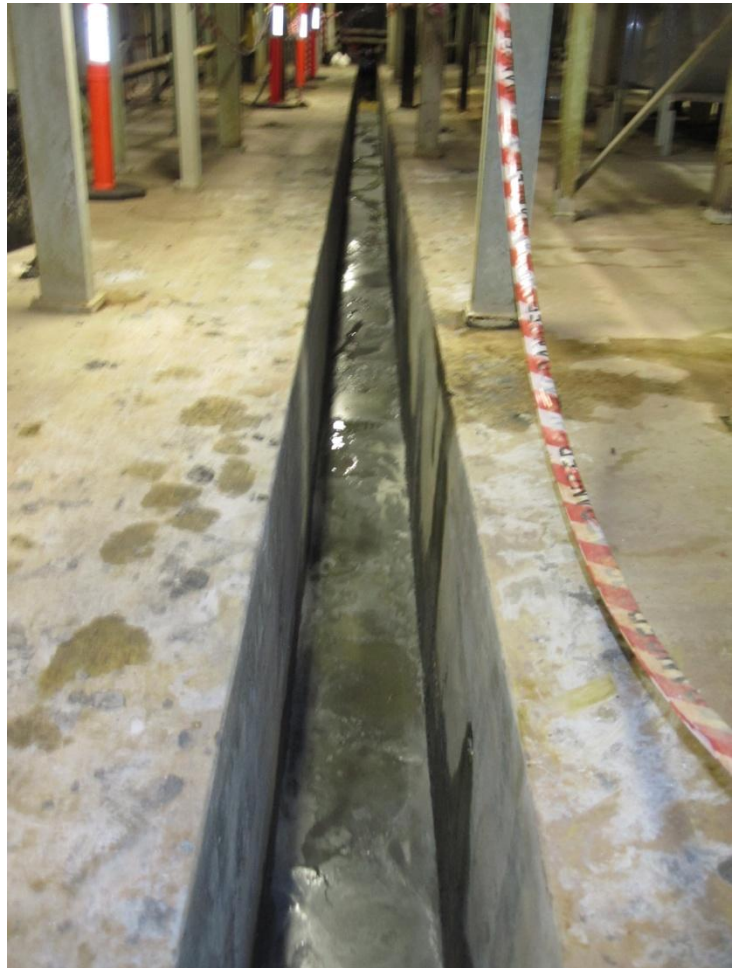
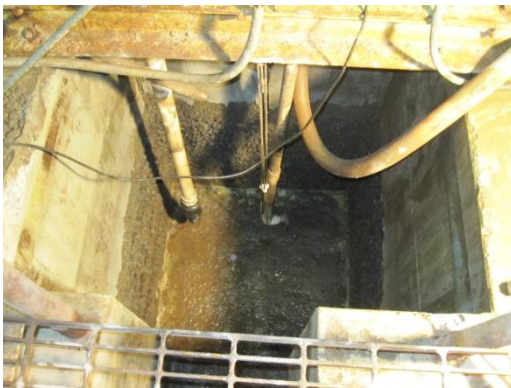
DGL was contracted by LTQ to repair their severely damaged concrete trench that drained highly corrosive material from their Electro Plating Shop. The job involved:

- Cleaning away all loose material from the trench using high pressure water
- Repairing the floor and walls of the trench using a high build repair mortar
- Installing a highly chemical resistive coating to reduce the damage caused by the chemical runoff
