Winchelsea Heritage Bridge Restoration

Vic Roads

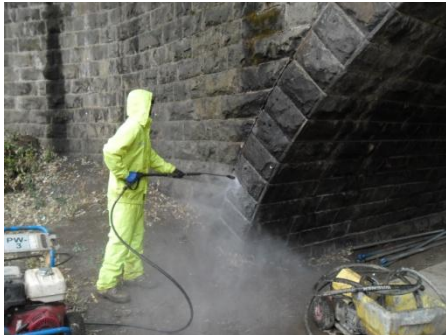
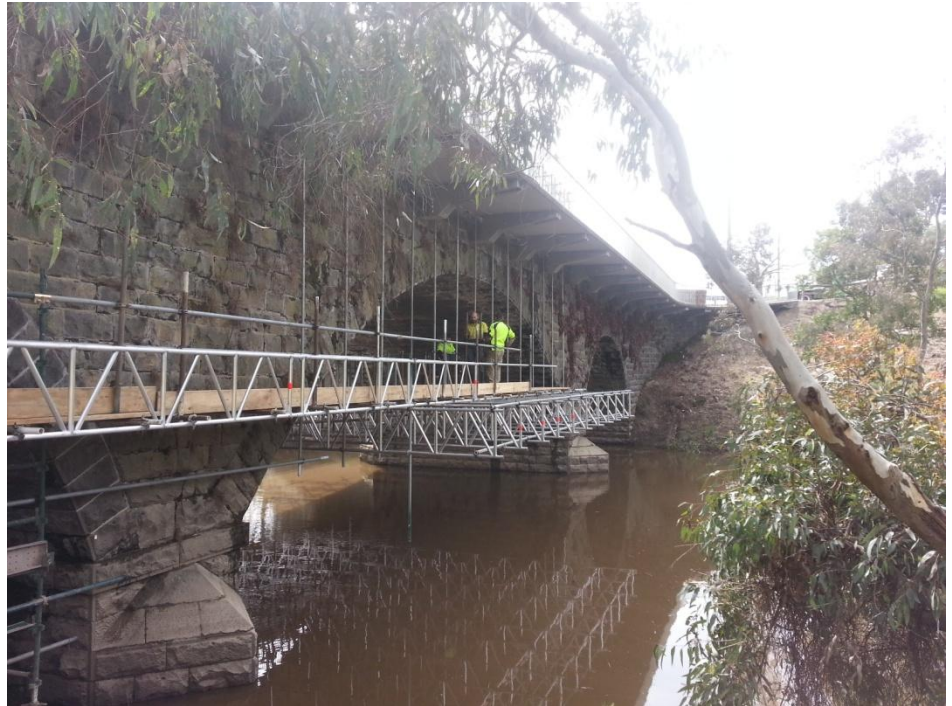
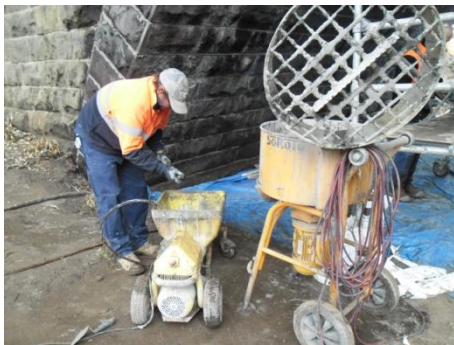
DGL was contracted by VicRoads to undertake the restoration of a heritage listed bridge in Winchelsea over the Barwon River. The job involved

- Setup of suspended working platform
- Removal of the existing pointing material
- Installation of grout injection tubes
- Re pointing with approved mortar
- Injecting grout behind bluestone to stabilise the arch
